MERRIMACK RIVER BASIN  
LOUDON, NEW HAMPSHIRE

# SANBORN POND OUTLET DAM NH 00182

## PHASE I INSPECTION REPORT NATIONAL DAM INSPECTION PROGRAM

MAY 1980

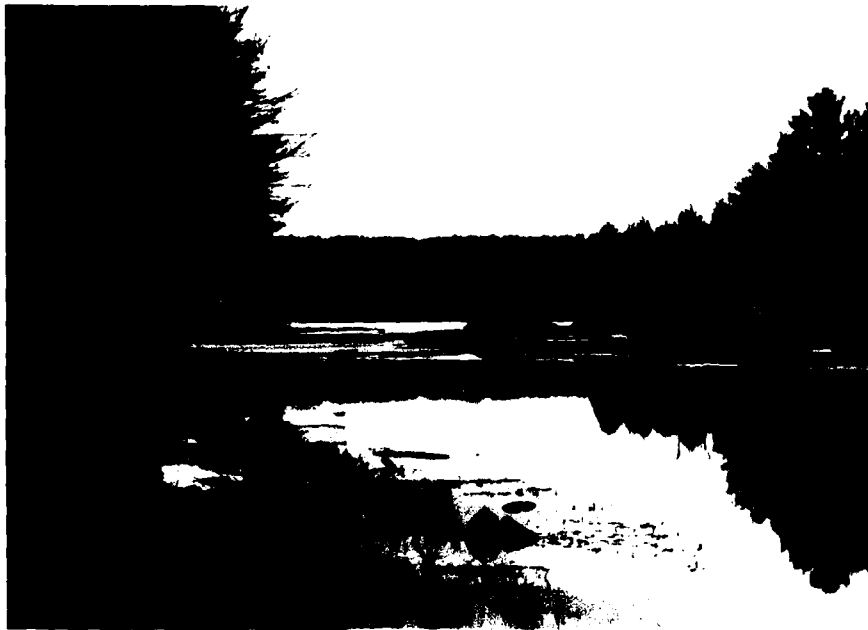
Photo No. 1 - General view of pond from right shoreline.

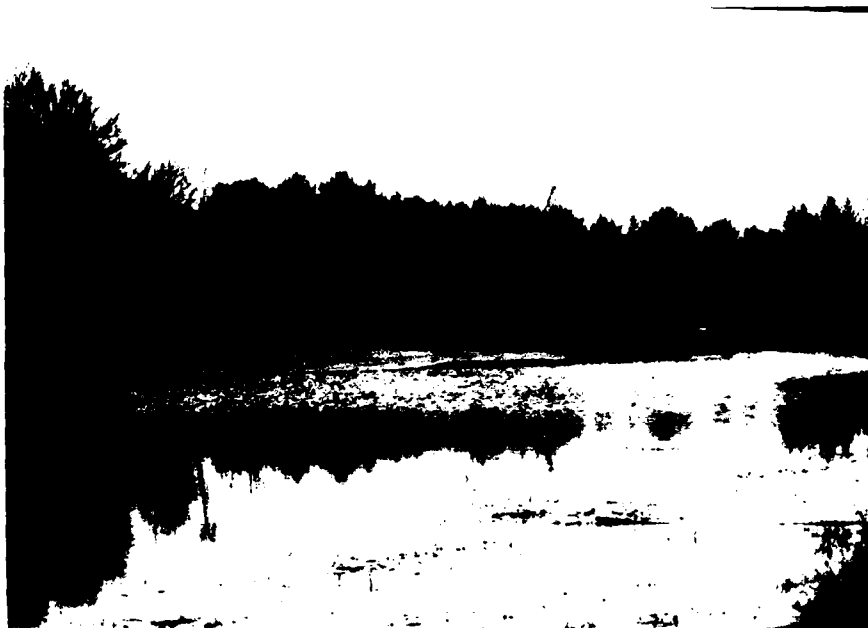
Photo No. 2 - General view of dam from pond.

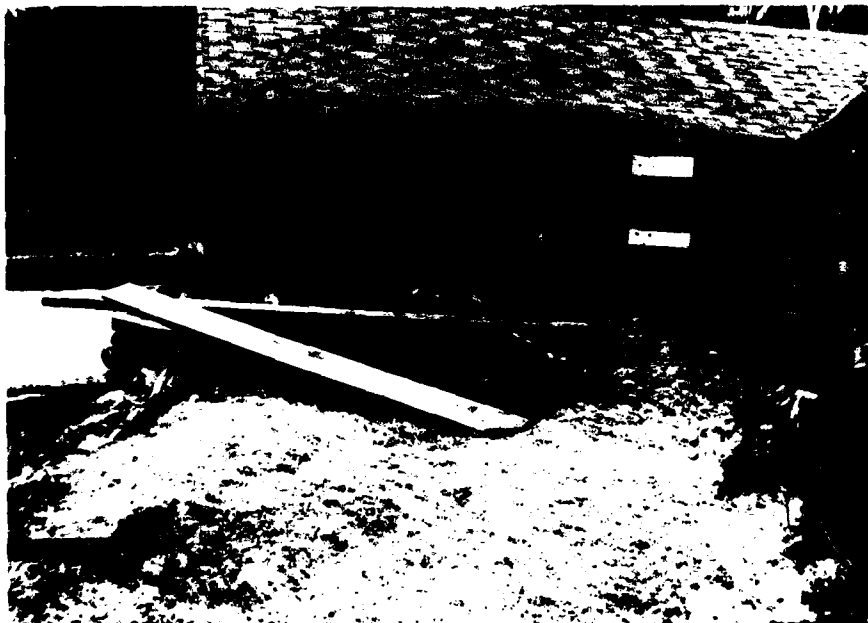
Extensive irregular settlement of the crest of the embankment, the poor condition of the vertical dry stone masonry walls which retain the upstream and downstream faces of the embankment, and the presence of what appears to be a wooden plank cutoff wall in the crest, in the vicinity of the penstock intake structure, all indicate that the embankment is in poor condition and may be unstable.

Photo No. 6 - Wood plank sheet piling and depression in crest of dam to the right of the mill intake structure.

- (1) Investigate the cause of the irregular settlement of the crest of the dam, the poor alignment of the dry stone masonry walls which retain the upstream and downstream faces of the embankment, and the condition of the embankment in the vicinity of the spillway and penstock intake structure, and design remedial measures if needed.
